Missouri Department of Natural Resources

Total Maximum Daily Load Information Sheet

Hinkson Creek

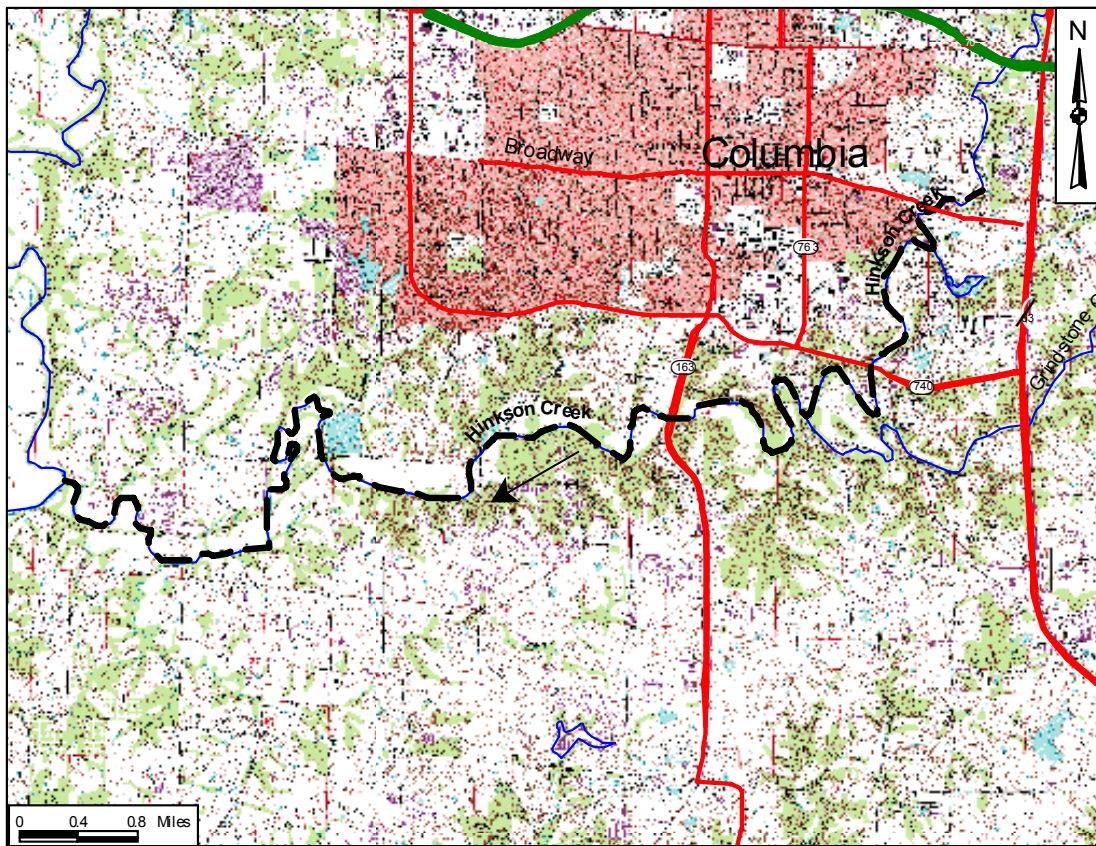
Hinkson Creek in Boone County, Missouri

--- Impaired segment ← Direction of flow

The impaired portion of Hinkson Creek starts south of route I-70 and runs through the city of Columbia to its confluence with Perche Creek. Although Hinkson's pollutants and sources are listed as unknown, water quality problems typically associated with streams in urban areas include:
